City of Henderson
Fire Safety Engineering
Informational Bulletin

Issue 014

TOP TEN

COMMON ERRORS ON SPRINKLER DRAWINGS (PART 2 OF 2)

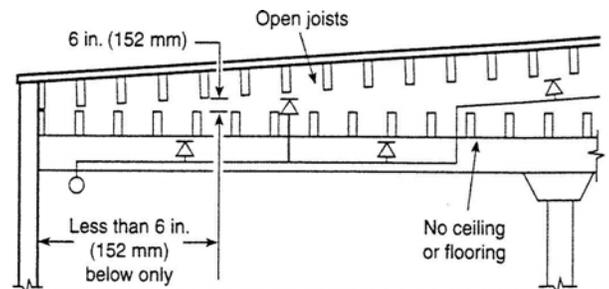
9. Attic coverage (upright heads) along roof trusses shall extend from the peak to the end of the truss, not to the point where the space between the top and bottom cords is $> 6"$ clear.

Arrangement of Sprinklers Under Two Sets of Open Joists - No Sheathing on Lower Joists.
